UNDERWATER BRIDGE INSPECTION REPORT

STRUCTURE NO. 9517

SOUTH CHANNEL OF THE ST. LOUIS RIVER

DISTRICT 1 - CARLTON COUNTY, CITY OF CLOQUET

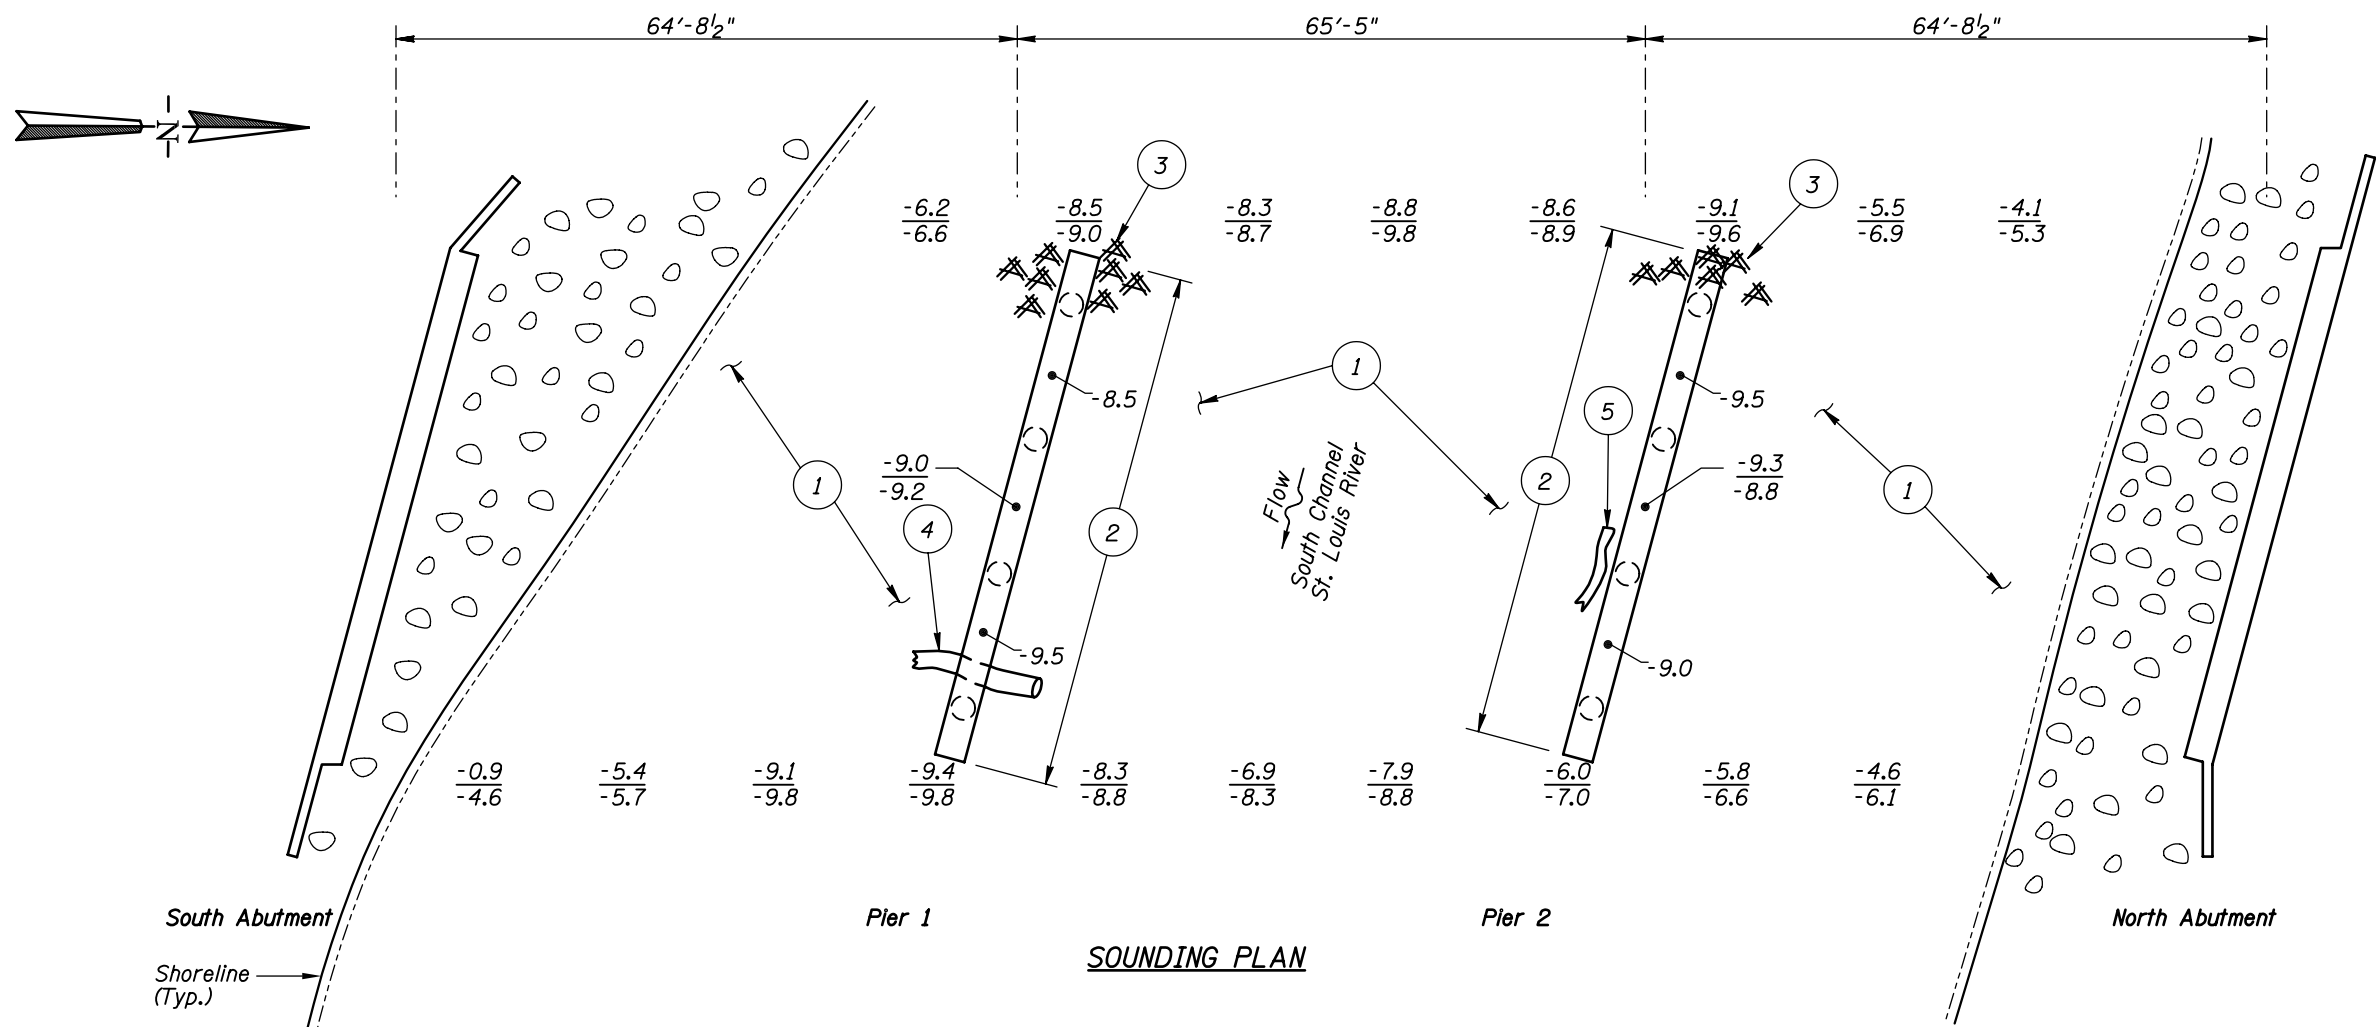
- 1 The channel bottom material consisted of 1- to 3-foot-diameter riprap with no probe rod penetration.
- 2 The steel pipe piles exhibited minor coating failure and up to 1/2-inch-diameter rust nodules over 5 to 10 percent of the surface area with no related section loss.
- 3 A minor accumulation of 4-inch-diameter and smaller timber debris was observed on the channel bottom at the upstream ends of both piers.
- 4 An 8-inch-diameter log was observed on the channel bottom.
- 5 A 6-inch-diameter log was observed on the channel bottom.

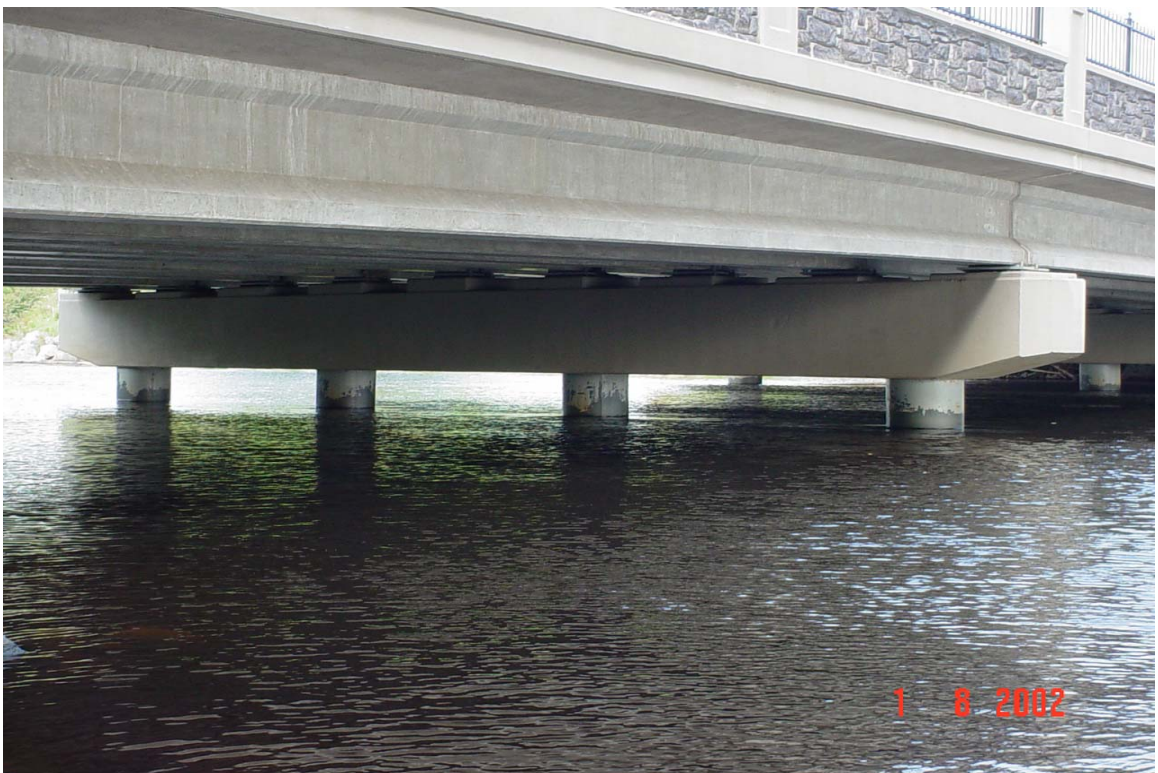
- (A) The steel pipe piles exhibited minor coating failure and up to 1/2-inch-diameter rust nodules over 5 to 10 percent of the surface area with no related section loss.
- (B) A minor accumulation of timber debris was observed on the channel bottom at the upstream end and randomly scattered throughout both piers.

Photograph 2. View of Pier 1, Looking Northwest.

- (A) Reinspect the submerged substructure units at the normal maximum recommended (NBIS) interval of five (5) years.

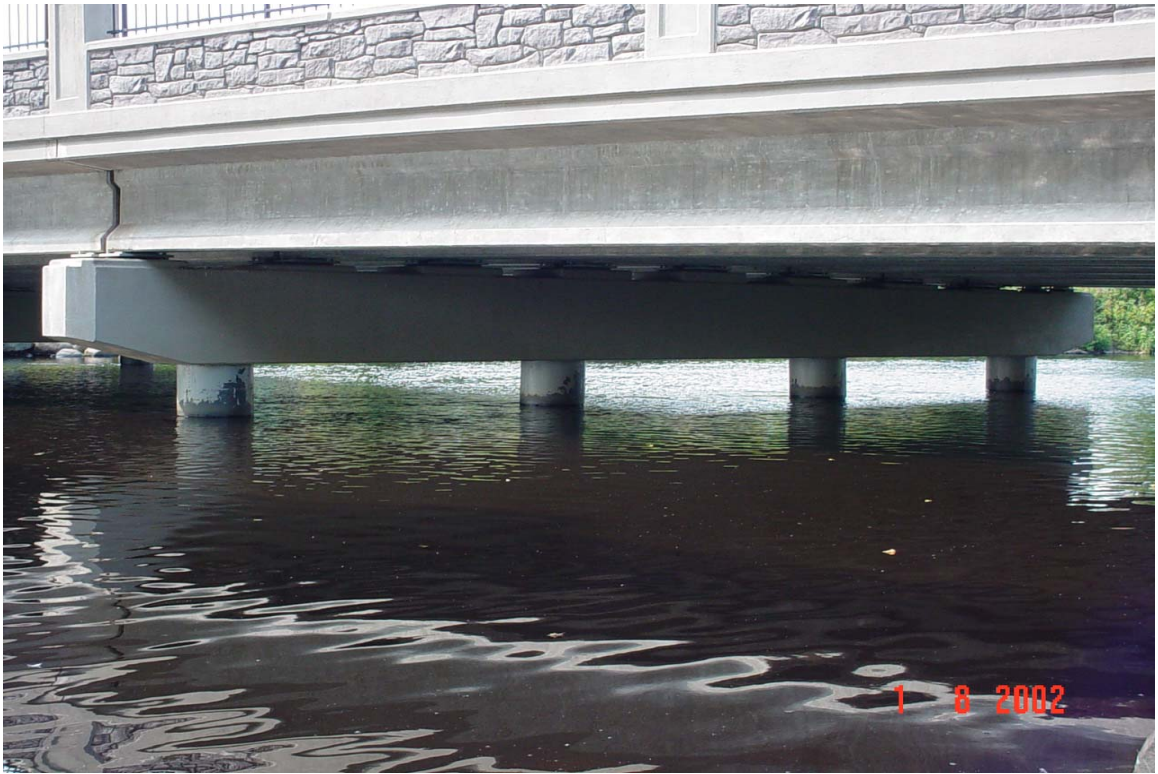
Photograph 3. View of Pier 2, Looking Southwest.
